# **Case Report**

# Heartmate II left ventricular assist device extensive driveline fracture: hanging on by a thread

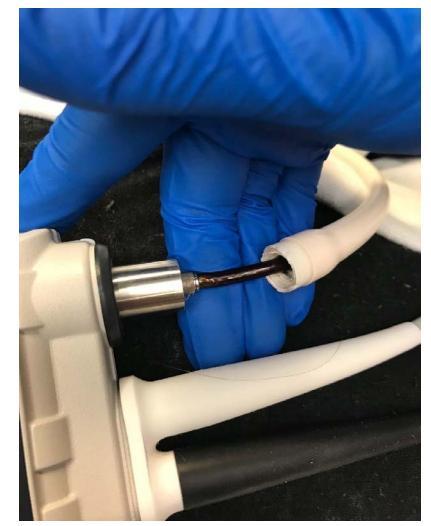
Figure 1. LVAD driveline reflecting silicone damage, discontinuity, and environmental exposure

stoppage. This patient's driveline had silicone damage and discontinuity for some time as the clear covering around the driveline wires had become dark brown with environmental exposure (Figure 1). Extent and location of driveline compromise can be difficult to evaluate with x-ray images; however, this patient's images were unique in the clear demonstration of fractures. Generally, external splicing repair of the driveline is attempted before surgical repair if only one of the two paired wires in a driveline is suspected to be damaged. If driveline damage is extensive, thought to be internal, or if hemodynamic compromise is associated, more urgent operative intervention for exchange of the LVAD to replace the driveline needs to be considered. For this patient, manipulation of the driveline even a few millimetres resulted in pump stoppage and hemodynamic collapse; the extent of presentation in this case was dramatic and required constant human stabilization during all the time preceding definitive exchange. In some situations where patients are deemed non-operative, an ungrounded cable may be provided. Early identification of suspected LVAD driveline fracture is necessary to allow for patient stabilization, verification and ascertaining extent of compromise and evaluation of appropriate interventions to sustain ongoing LVAD support.

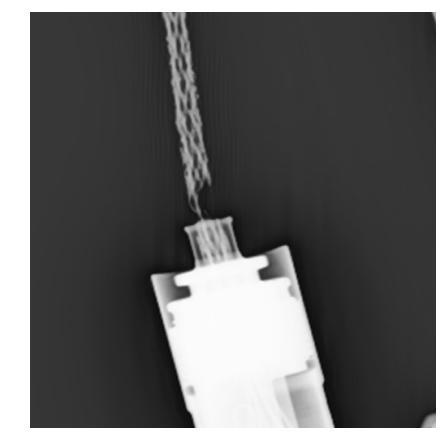
Figure 2. X-ray image of LVAD driveline revealing significant damage with only 1 of 6 wires intact
