Guidelines for restoring fractured central incisors

Faced with fractured central incisors, many solutions are available, and the practitioner must choose the appropriate one. Rehabilitation of the compromised teeth number 11 and 21 was performed with lithium disilicate veneers. The purpose of this clinical case is to outline the treatment approach and to highlight the different guidelines to establish function and esthetic using ceramic veneers.

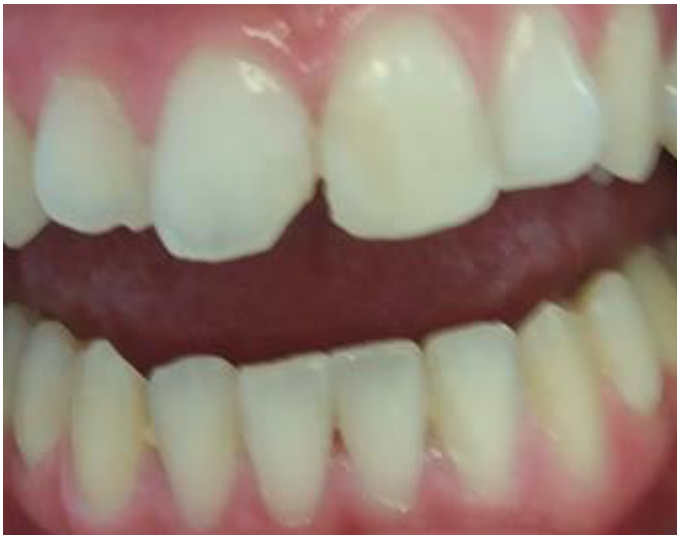
Intraoral examination revealed that the right central incisor was fractured in the middle-third of the crown, involving enamel and dentin without pulp exposure (Figure 2) and without symptoms of concussion or contusion, the left central incisor was restored by composite, but she complained from it repetitive loss. Oral prophylaxis was done, and dental hygiene maintenance instructions were given. Radiographic examination and tooth vitality tests were positive. Anterior guidance was evaluated.

Figure 2. Facial view of fractured central incisors (Right incisor was restored by composite)

Several approaches for recovery of the esthetics and the masticatory function, depend on the type and extent of tooth fracture; In this case, the fracture is in enamel and dentin with a loss of much tooth structure, the use of ceramic veneers is an excellent and suitable alternative.

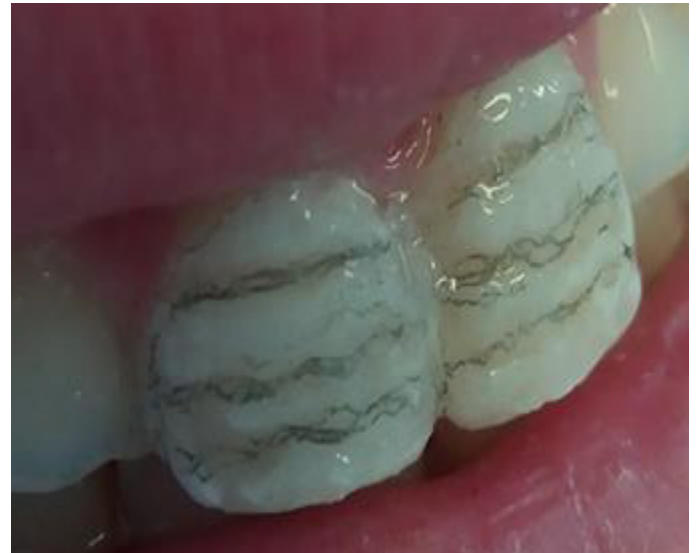
Figure 3. Starting teeth preparation within the mock-up

Failure to do this may result in excessive and unnecessary removal of tooth enamel. Tooth should be prepared within the enamel whenever possible. In this case depth limiting burs were used to prepare directly through the bis-acryl mockup, as described by Gurel (2003) (Figure 3). The teeth were prepared with a marginal chamfer labially and interproximal, and a butt fit margin palato-incisally with wrap around onto the palatal aspect as described by Castelnovo et al, 2000 (Figure 4). Contact points were not preserved, to allow freedom for the technician to change the width and shape in the final restoration. Ensure smooth finish lines and surfaces, using 40-micron diamond abrasives. A smooth surface avoid stress under the veneer and a more uniform thickness of cement. This also leads to better adhesion.

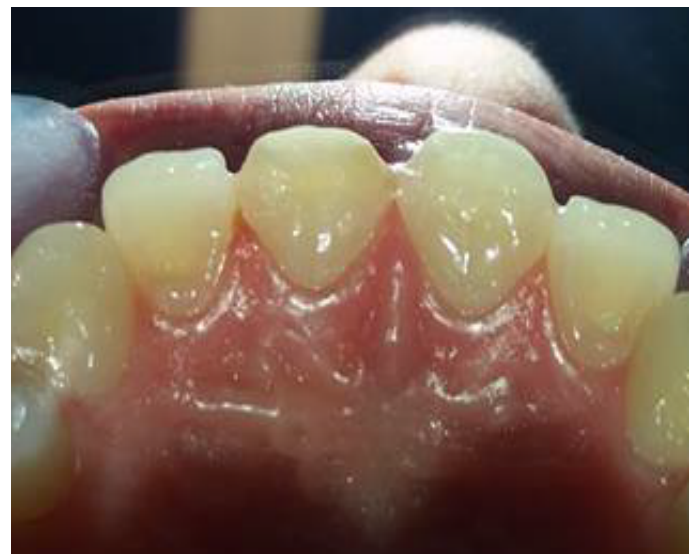
Figure 4. Palatal view of preparation

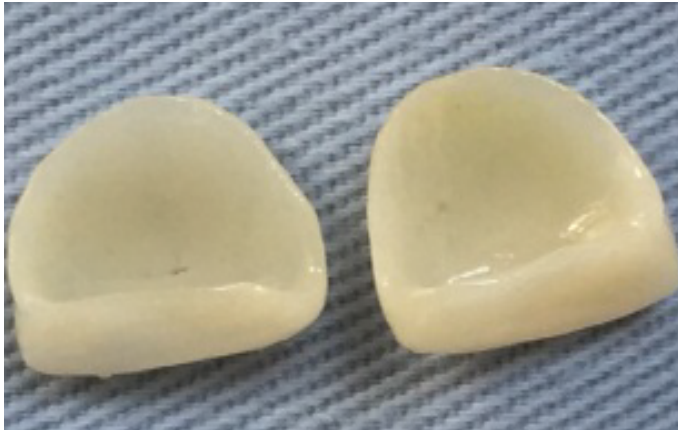
Figure 5. IPS e max veneers

Lithium disilicate veneers were aided by computer(CAD), by coping the contours from the diagnostic wax-up. (Figure 5) Veneers were individually checked intra-orally to control gingival margins adaptation, the complete seating and embrasure opening, and occlusion. Then, shade and esthetics were well checked

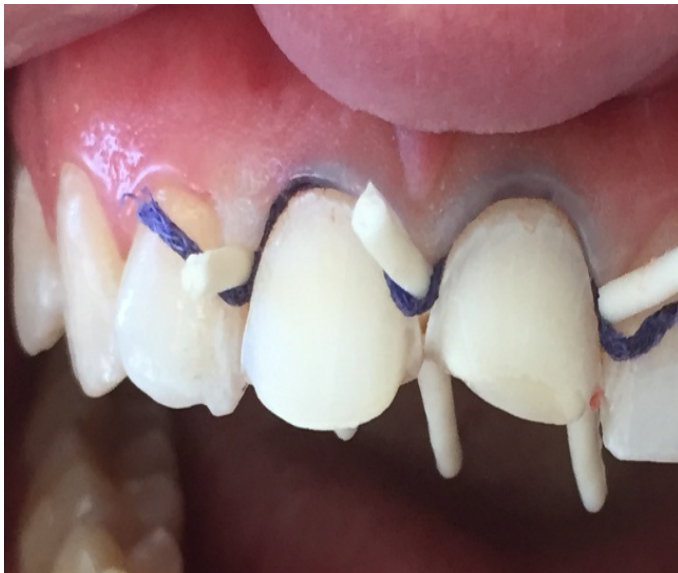
Figure 6. Gingival retraction for a secure bonding

After adequate gingival retraction (Figure 4), a two-step dual impression was made and sent to the laboratory for fabrication of lithium disilicate (IPS e max cad) veneers.

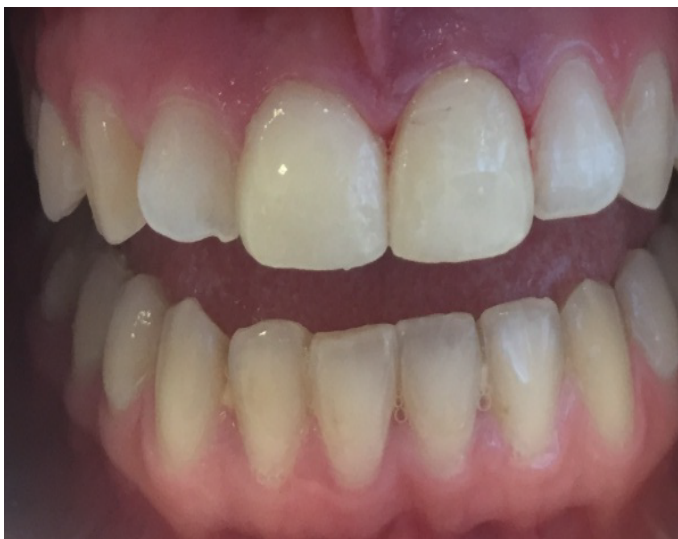
Figure 7. Final situation; veneers bonded in place

At the end of the treatment, the patient was pleased with the results and no longer hides her smile (Figures 7 and 8).

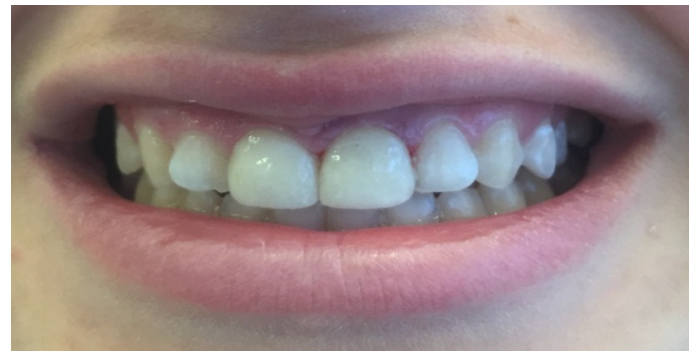
Figure 8. Post-operative appearance of Smile

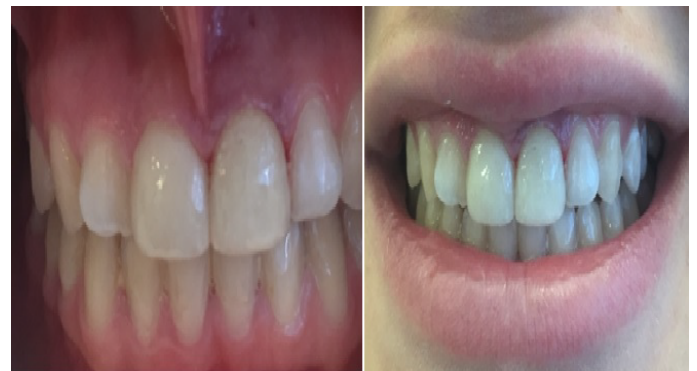
Figure 9, 10. Natural look of teeth restored after two months. Satisfying esthetic outcome. characterizations reproduction, periodontal integration and function

Periodic follow-up was scheduled to evaluate the gingival health and patient comfort and satisfaction (Figures 9 and 10).
