Removal of a malpositioned implant and immediate re-implantation during healing period

The present clinical case report describes an alternative technique for the surgical management of an unfavorable implant position by relocating the same implant during the postoperative period.

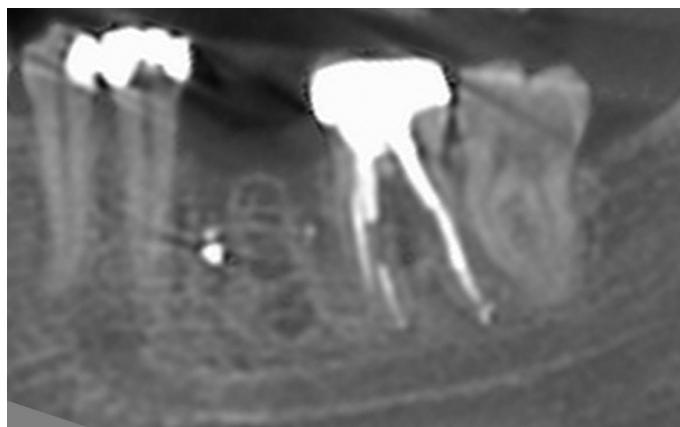
Figure 1. After completion of a five months postextraction period, the alveolar socket of the extracted tooth (no 19) was not fully healed.

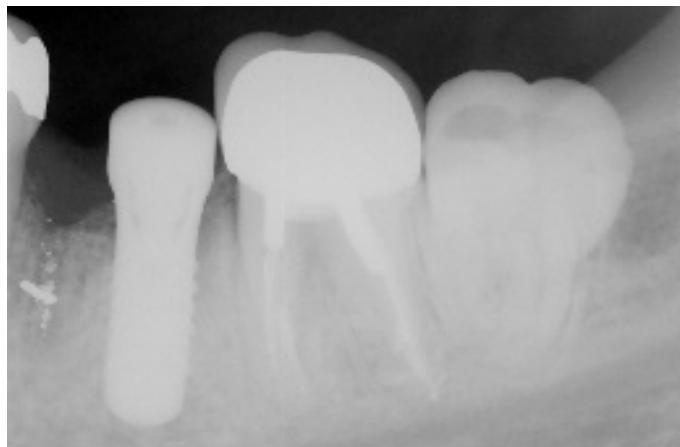
Figure 2. An implant was placed in the position of the distal root of the extracted first lower molar and close to second molar.

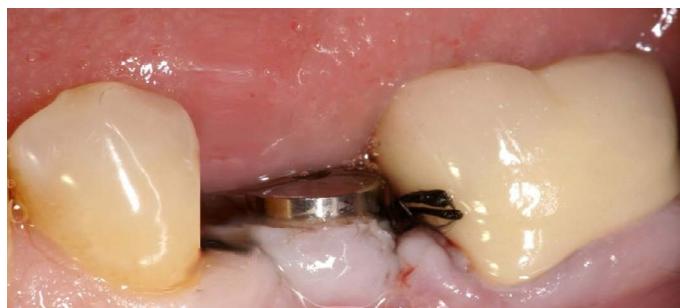
A 39-year-old Caucasian non-smoking female was referred to a specialist for implant treatment. The patient was in good general health and did not have any subjective dental complaints except of a malpositioned dental implant. The dental history revealed that, six months ago, her general dentist extracted the first left lower molar (tooth no 19) planning to replace it with a dental implant. After completion of a five months postoperative period, the dentist intended to place an implant with diameter 4.8 mm and length of 12mm (Straumann®, Standard Plus Implant System, Institute Straumann AG, Basel, Switzerland). During surgery, he noticed that the alveolar socket of the extracted tooth (tooth no 19) was not fully healed despite the prolonged postoperative period (Figure 1) and in agreement with the patient, decided to insert the implant in the position of the distal root (distal aspect of the socket) and close to second molar (Figure 2). After suture removal, he reconsidered the treatment plan based also on his dental technician opinion and patient will, as a successful prosthetic rehabilitation couldn't be ensured (Figure 3).

Figure 3. Due to implant malposition a successful prosthetic rehabilitation couldn't be ensured.

Therefore, he referred the patient for implant removal and re-implantation.

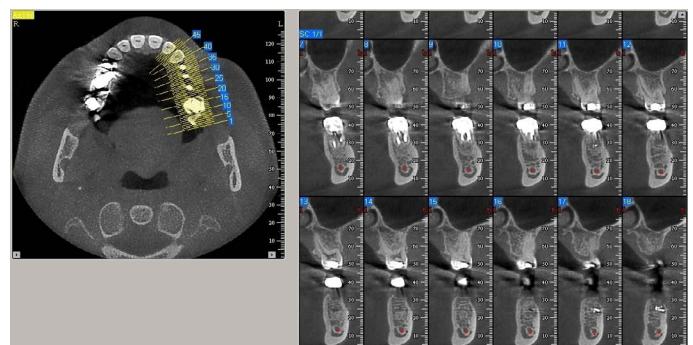
Preoperatively, the alveolar bone volume was assessed based on previous CT scan radiographic examination (Figure 4). Adequate bone height of 15 mm away from alveolar nerve and width of 9 mm

was estimated. The relocation of the same implant (4.8 x 12 mm) in the middle of the edentulous area was attainable. The patient received antibiotic prophylaxis prior to surgery.

Figure 4. Preoperatively, the alveolar bone volume was assessed based on previous CT scan radiographic examination.

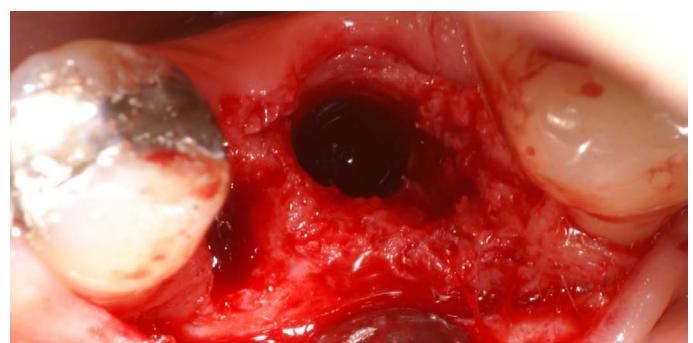
Figure 5. After careful elevation of the mucosal layer, the alveolar ridge between lower left second premolar and molar was exposed and the implant was removed.

After careful elevation of the mucosal layer, the alveolar ridge between lower left second premolar and molar was exposed and the implant was removed without any damage of the alveolar bone or the material (Figure 5). Implant removal was accomplished by applying the manufacturer implant transfer part and the ratchet and turning it initially clockwise (like ending insertion procedure) with a high torque more than 50 N/cm up to disconnect the immature bone implant contact and afterwards counterclockwise for implant retrieval. The removed implant was submerged in a dish with blood and saline and used again after socket debridement (Figure 6). Thereafter, the alveolar socket (mesial aspect) was exposed and cleaned with bone curettes as complete wound closure had not been achieved. The removal of debris from the socket was completed by irrigation with saline. The empty space of the mesial socket defect and the implant cavity after explantation was filled with 0.5 cc xenograft granules of 0.25 to 1 mm in diameter (BioOss®, Geistlich Pharma AG, Wolhusen, Switzerland) to facilitate the proper guidance of drilling and implant insertion. Therefore, implant placement was performed in a proper position according to manufacturer guidelines with the exception of low speed drilling (200-400 rpm) with minimal water cooling to avoid graft particle loss (Figure 7). The implant remained submerged with flap closure. Sutures were applied and postoperative instructions were given. Antibiotic coverage of 500 mg amoxicilline times per day was applied. Postsurgical pain and edema were controlled with 600 mg ibuprofen three times per day, and the patient was instructed to rinse twice daily with 0.12% chlorhexidine for two weeks and to use modified oral hygiene procedures in the treated area for the first six postoperative weeks.

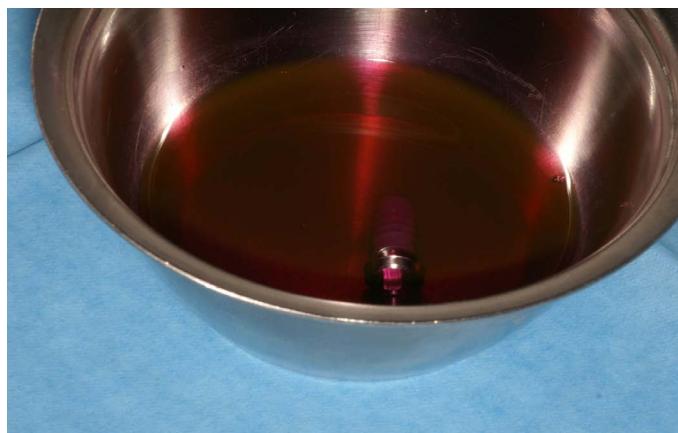
Figure 6. The removed implant was submerged in a dish with blood and saline and used again after socket debridement.

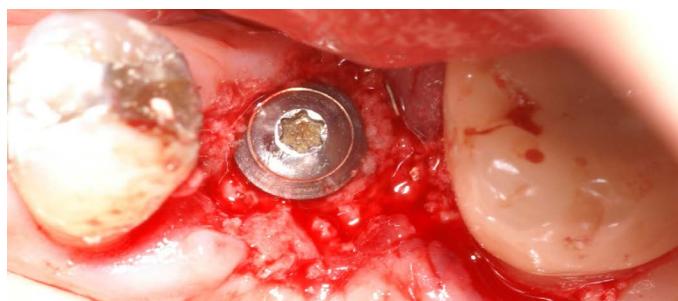
Figure 7. Implant placement was performed according to manufacturer surgical guidelines in a proper position.

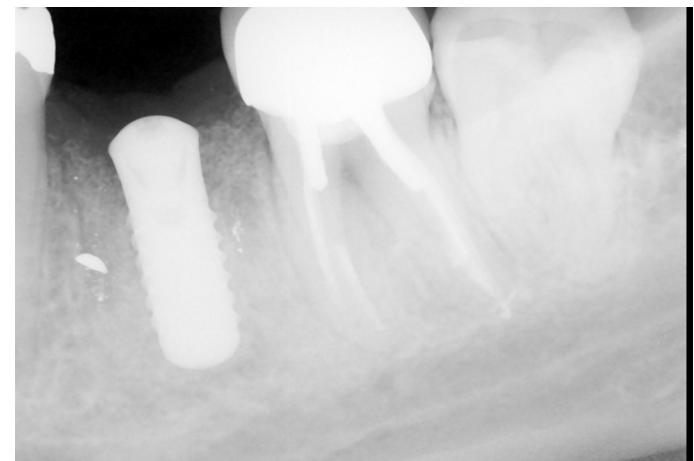
The patient was examined two weeks later and the sutures were removed. Radiographic examination was also performed (Figure 8). The patient was maintained in a supportive care program and control appointments once per month were scheduled. Five months after insertion, the implant was exposed and an abutment was connected. A single metal ceramic crown was fabricated four weeks later (Figure 9). One year after prosthetic rehabilitation, a reevaluation of the case was performed. The general periodontal status was stable and the patient had achieved a very good level of plaque control. No dental complaints were reported. Clinical examination of the implant placed in the augmented area revealed no mobility and healthy peri-implant mucosa. The radiographic examination confirmed bone-implant contact without any sign of radiolucency around the implant (Figure 10). Further the patient has completed three years of functional loading, following annual check-up with no additional clinical findings.

Figure 8. Radiographic examination was performed two weeks after implant relocation in a suitable position.

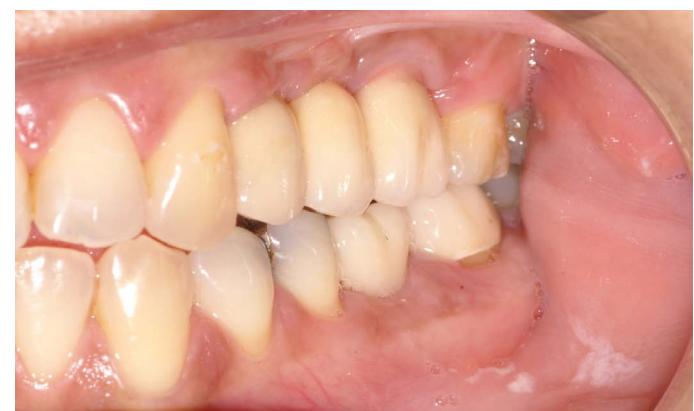
Figure 9. Clinical view of the prosthesis that was fabricated six months after implant placement.

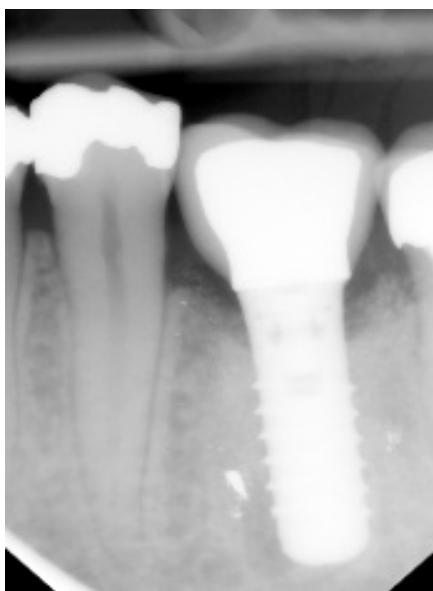
Figure 10. The radiographic examination confirmed bone-implant contact without any sign of radiolucency around the implant.
