# Short-term, Emergency Management of an Endodontically-treated Tooth with a Dislodged Crown

Recurrent caries or fracture of the remaining tooth structure under existing crowns are among the most common occurrences in restorative dentistry, which may lead to dislodgement or loss of these restorations. A short-term management of endodontically-treated teeth with dislodged crowns is discussed.

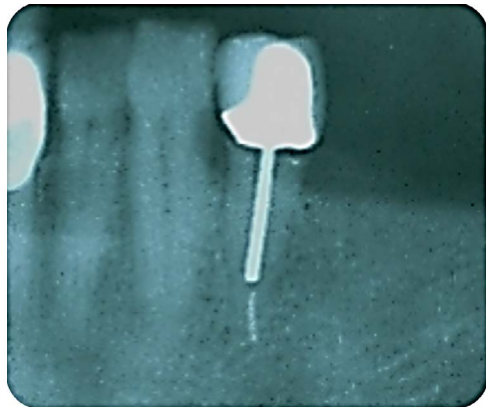
A 55-year-old female with a noncontributory medical history presented with a loose metal-ceramic crown on her mandibular left first premolar. Her periapical radiograph showed an existing endodontically-treated root, a prefabricated post, and a metal-ceramic crown with an open margin (Figure 1). In addition, she was missing the rest of her posterior teeth in that quadrant. A removable partial denture had been previously made for her, but she did not feel comfortable and did not wear it, except occasionally.

Figure 1. Periapical radiograph of the affected tooth.

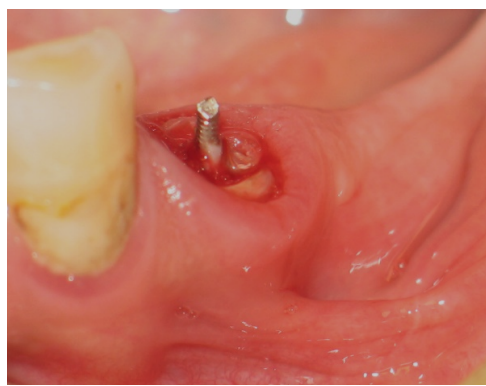
The dislodged crown was still loosely attached to the prefabricated post, but the post was still in place and there was no sign of recurrent caries invading the canal, judging by its intact cement line (Figures 2 and 3).

Figure 2. Remaining prefabricated post.

1. The prefabricated post was removed by using an ultrasonic device (Dentsply Cavitron) to break the cement seal followed by careful extrusion of the post by means of a post-puller.

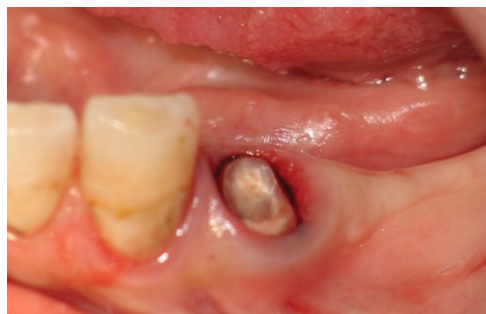
Figure 3. Prepared tooth before post and core pattern.

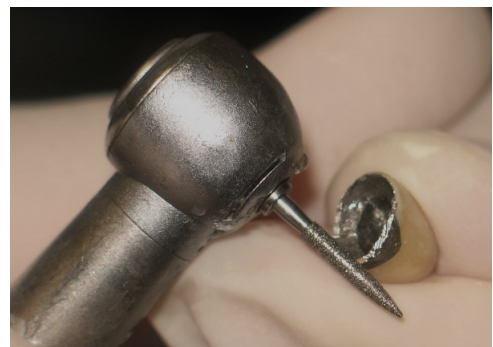
Figure 4. Modification of the crown margin.

2. After complete removal of the remaining cement, a #1 knitted retraction cord (Ultrapak, Ultradent) was placed into the gingival sulcus for better visibility and moisture control.
3. A 1mm bevel was prepared to extend the finish line into the gingival sulcus and increase the ferrule (Figure 4).
4. Margin of the existing crown was modified to a butt-joint to improve its duplication by the pattern resin (Figure 5).
5. A post pattern was made following the standard technique with a plastic dowel (Spee-Dee point, Pupdent) and a pattern resin (GC, Inc.).
6. The intaglio of the modified crown was lubricated with a thin layer of petroleum jelly, filled with a small amount of pattern resin mixture, and inverted over the abutment tooth, verifying the correct position by patient's occlusion.

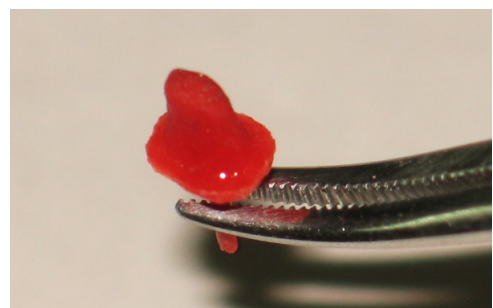
Figure 6. Post and core pattern before casting.

7. The crown was removed, and the core pattern was completed by adding some resin to the modified finish line of the tooth (Figure 6).
8. The pattern was removed from the tooth, the margins were refined (Figure 7), and it was cast in a cobalt-chromium alloy (Figure 8). The patient was dismissed after sealing the root with a cotton pellet covered by glass ionomer restorative material and removing the retraction cord.
9. During the following appointment, accuracy of the casting into the prepared tooth and the crown were checked separately (Figures 9 and 10), and in combination (Figure 11). A periapical radiograph was taken to confirm the clinical observation before the final cementation.

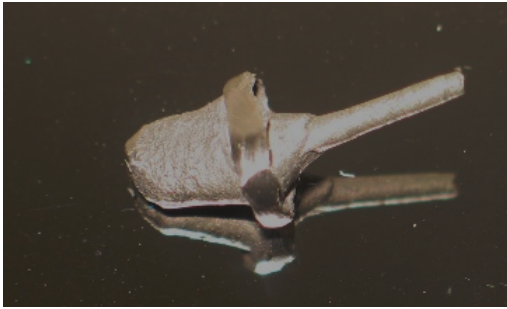
Figure 7. Cast post and core.

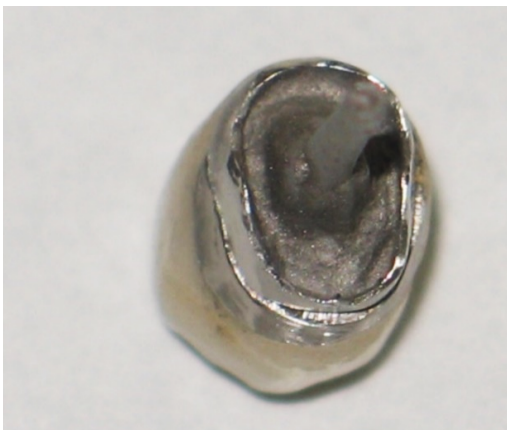
Figure 8. Cast post and core try-in inside the crown.

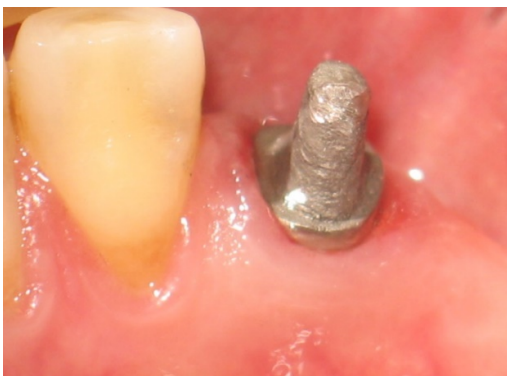
Figure 9. Cast post and core try-in on the tooth.

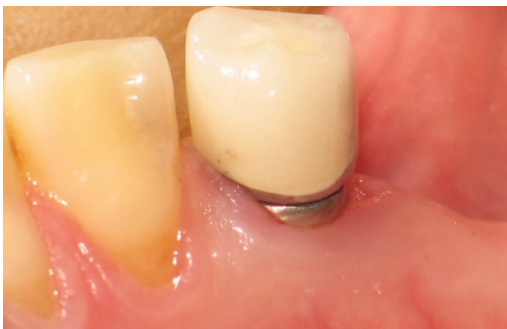
Figure 10. Cast post and core and crown before cementation.

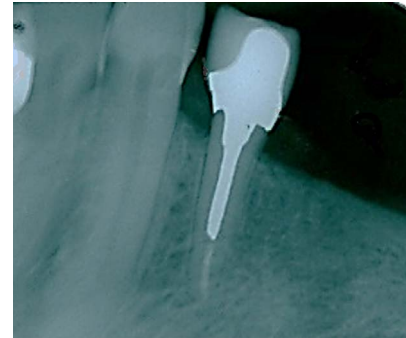
Figure 11. Periapical radiograph of cast post and core and crown before cementation.
